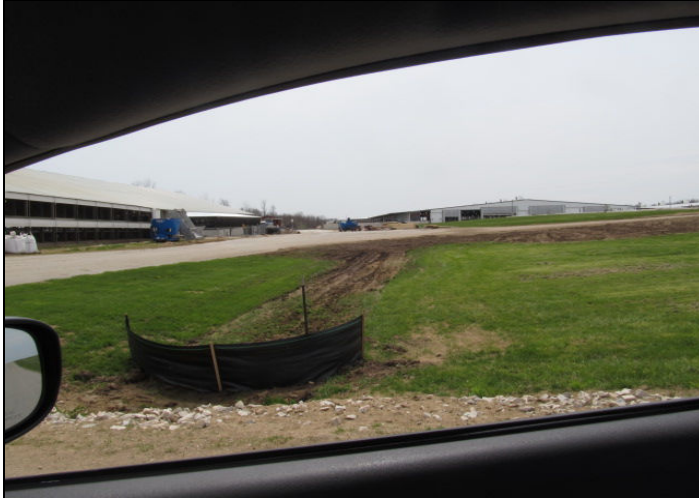
Photo #:	001
Date/Time of Photo:	5/19/2014
Photo Location:	Main Dairy
Photo By:	Danielle Block
Photo Description:	Photo taken facing south. Stormwater diversion scrapped of windblown digester solids, silt fences put in place.

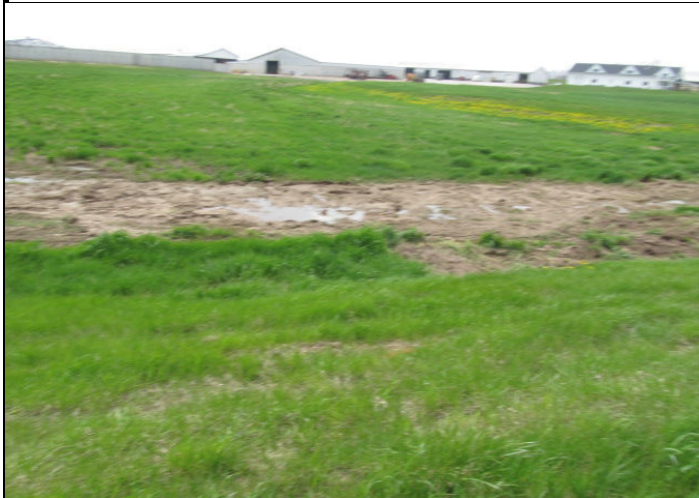
Photo #:	002
Date/Time of Photo:	5/19/2014
Photo Location:	Main Dairy
Photo By:	Danielle Block
Photo Description:	Photo taken facing southwest. Tile line in field south east of VTA fixed, channelized flow path from the tile line regraded.

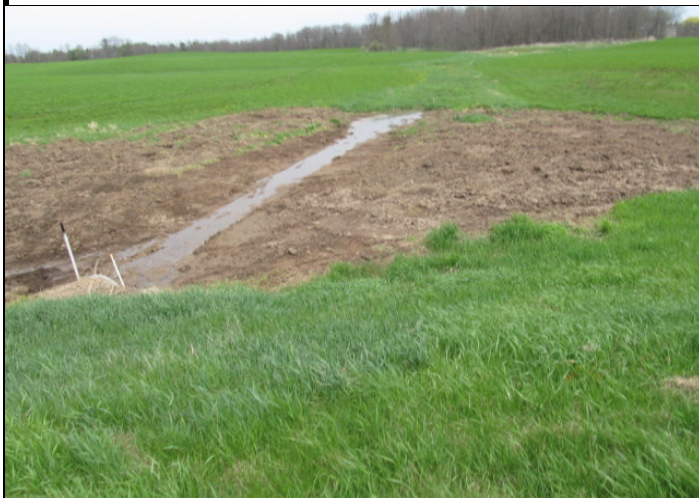
Photo #:	003
Date/Time of Photo:	5/19/2014
Photo Location:	Main Dairy
Photo By:	Danielle Block
Photo Description:	Photo taken facing north east. Grassed waterway north of County Rd C, culvert opposite side to the end of the VTA, was scrapped.

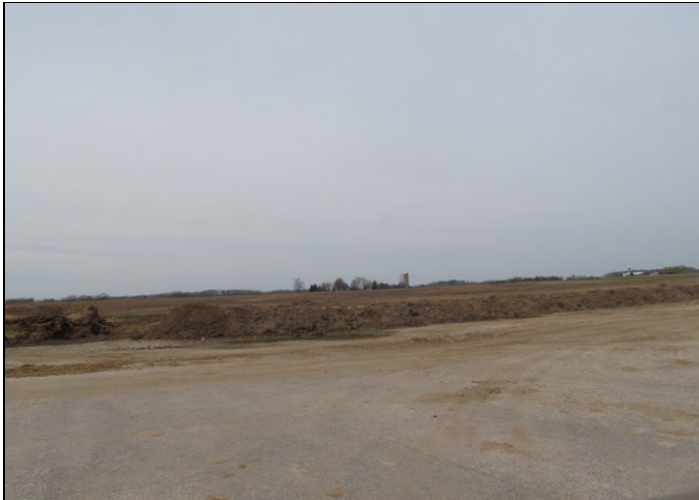
Photo #:	004
Date/Time of Photo:	5/19/2014
Photo Location:	Clyde Hill Facility
Photo By:	Danielle Block
Photo Description:	Earthen berm in place near manure storage.

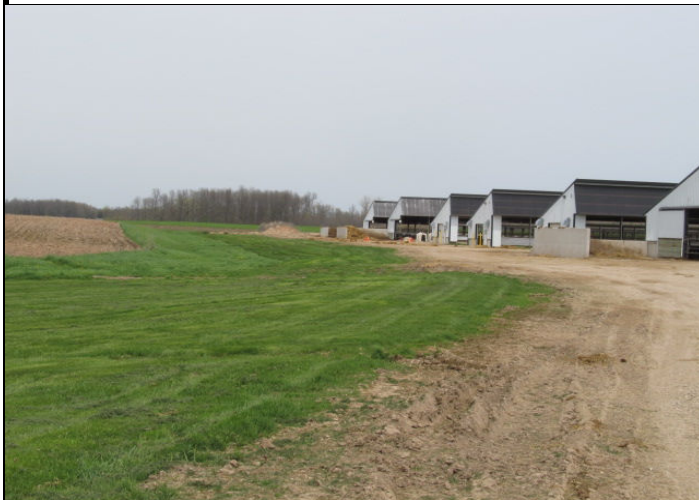
Photo #:	005
Date/Time of Photo:	5/19/2014
Photo Location:	Clyde Hill Facility
Photo By:	Danielle Block
Photo Description:	Calf hutches moved from the west side of facility.

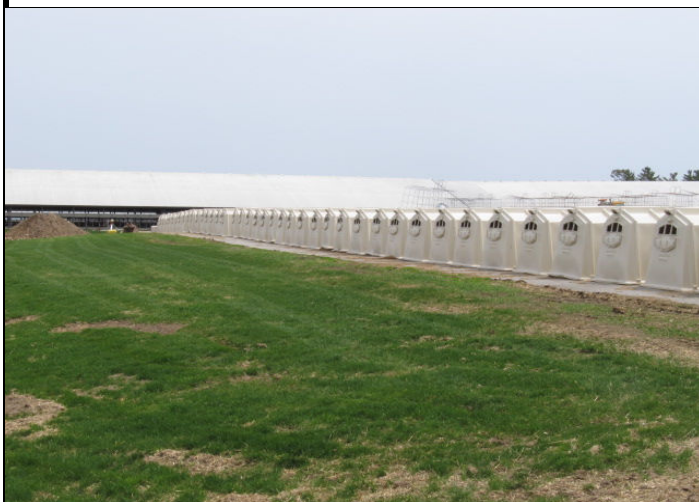
Photo #:	006
Date/Time of Photo:	5/19/2014
Photo Location:	Clyde Hill Facility
Photo By:	Danielle Block
Photo Description:	Calf hutches moved off of grass on to concrete pad.
